Failed Bridges

Case Studies, Causes and Consequences

Author: Joachim Scheer

11.2 Failure due to inadequate lateral stiffness

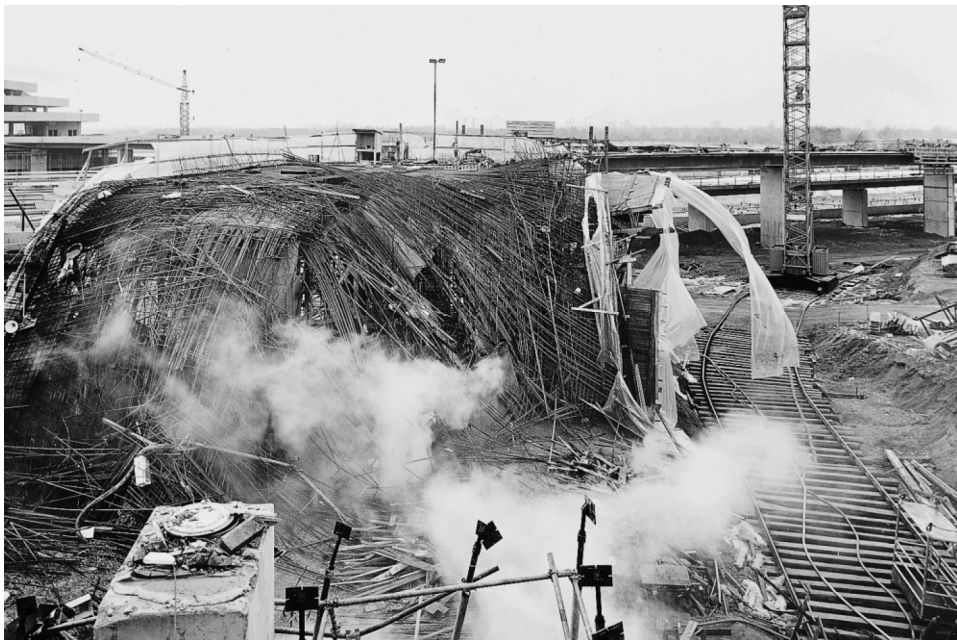
One example is the scaffolding for a bridge ramp at Cologne-Wahn airport, 1995, Case 11.45. The report [103] states that a number of errors contributed to the accident besides the lack of adequate bracing for the steel tubes butted together as props. The last approx. 50 m long section of the exit ramp was under construction when a serious accident occurred (Fig. 11.1). Steel shoring, consisting of swivelling head plates on spindles, extension tubes, standards, base plates and steel scaffold fittings, had been erected to support the formwork for the elevated reinforced concrete T-beam slab . . . Concreting work had got to the stage of the pouring and compacting of the wet concrete in the last third of the ramp when suddenly and without warning a 30 m section of the scaffolding collapsed. Not only was there a huge 750 t pile of concrete, steel and timber, but the heaters installed to produce warm air during the winter also toppled over, the heating oil leaked out and started a fire. Members of the concreting gang slid with the mass of concrete from a height of 10 m. Some workmen succeeded in

Fig. 11.1 Collapse of supporting scaffolding for a bridge ramp at Cologne-Wahn airport. 1995, Case 11.45

The inquiry was unable to explain the cause of the accident conclusively but the following deficiencies were found:

- General type approval certificates could not be produced for all scaffolding components.
- The scaffolding work was extremely defective, for example short tubes had often been joined together many times to form standards.
- Bracing connections were completely missing at some points. The upper horizontal bracing had often been joined to the thread of the spindles instead of to the extension tube, compensating the difference of diameter with wooden wedges.
- In some cases the scaffold couplings were not even closed.
- Due to a setting out error, the scaffolding had first been constructed too high and had to be corrected. This had been achieved using makeshift supports and wedges.
- Pin-ended columns were frequently not axially loaded.
- Some standards had simply been placed on the ground without base plates.

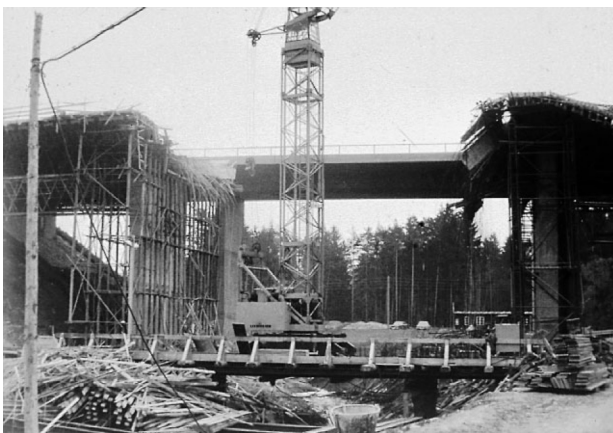
The scaffolding for the bridge over the River Leubas near Kempten in 1974, Case 11.24 is a typical example that has been frequently mentioned in engineering literature and in lectures. As I visited the site immediately after the collapse (Fig. 11.2), I can report from my interviews with those responsible how extrapolation from experience without due consideration of the conditions particular to the case in question can lead to fatal mistakes.

Fig. 11.2 Collapse of supporting scaffolding for a road bridge over the River Leubas near Kempten. 1974, Case 11.24

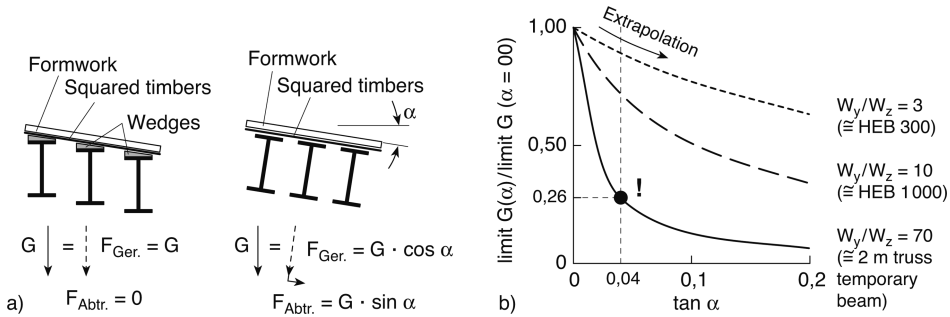
The bridge had a relatively high transverse cross-fall of $\alpha = \text{approx. } 4\%$. If the slab formwork had been placed on scaffolding with vertical temporary beams (Fig. 11.3a, left), wedges would have been necessary at each junction between beams and squared timbers - over 1000 wedges for the entire bridge. The temporary trusses would only have been stressed by the weight load (G) along their main axes (z). To reduce the work of the shuttering carpenters it was decided, as on other occasions for scaffolding with a shorter span but also using rolled-

Fig. 11.3 Collapse of scaffolding for a road bridge over the River Leubas near Kempten, 1974, Case 11.24

a) 2 possible scaffolding details for bridges with a crossfall

b) limitation of the load-bearing capacity $G(\alpha)$ by angle α , related to $G(\alpha=0)$

steel beams, to slope the beams with the same cross-fall as the slab formwork (Fig. 11.3a, right). The horizontal force component resulting from the weight of beams, formwork, reinforcement and concrete is therefore $F_{Abtr.} = G \cdot \sin \alpha$ at right angles to the axis of the web. The scaffolding designers failed, however, to assign this to the wind bracing = stabilization bracing. They rather assumed, without checking, as an extrapolation from previous scaffolding experience that this component would be absorbed by transverse bending in the beams without serious consequences for the structural safety of the scaffolding system. This past experience had been with smaller transverse gradients and rolled-steel beams with a relatively low ratio of the two resistance moments $W_y/W_z = \text{approx. } 3$. Transverse bending had only had a relatively small influence on structural safety (Fig. 11.3b). There were two important differences in the scaffolding for the Leubas bridge:

- the highly “stretched“, approx. 2 m high truss beams had a much higher ratio of section modulus: $W_y/W_z = \text{approx. } 70$ (W_y of the upper chord) and
- the cross-fall α of approx. 4 % was extremely high.

Fig. 11.3b makes these correlations clear. It shows 3 W_y/W_z ratios against the tangent of the angle of inclination α to the limit load $\text{limit } G(\alpha)$ for the inclined temporary beam to the limit value $\text{limit } G(\alpha=0)$ for the vertical beam.

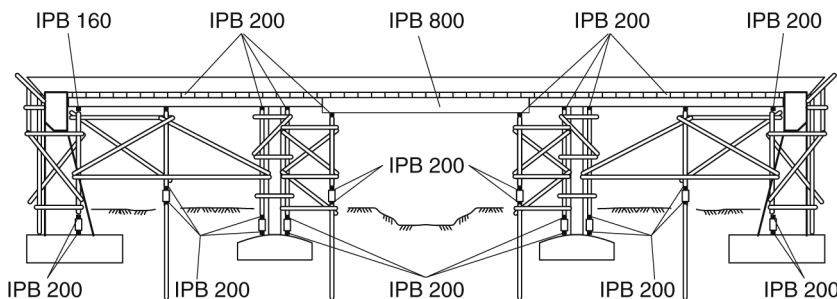
The drawing in Fig. 11.4 is taken from [5, p. 25]. It shows the scaffolding built of steel IPB beams on timber props. Between the towers standing on the foundations of the bridge piers and the abutment, there was an arrangement of single-walled intermediate trestles supported on timber piles. IPB 200 beams were located above and below the spindles on the baseplates. There was no bracing over a height of 1.3 m, nor across the longitudinal axis of the bridge. Some of the wooden piles projected more than 1 m out of the ground and were not braced. The collapse occurred in the middle of the main span which was bridged with IPB 800 temporary beams and held only by single-walled intermediate trestles.

The report [5] cites a large number of further deficits: reckless intermediate timber constructions between longitudinal and frame beams; the frame beams were not infilled under the longitudinal beams although concentrated loads of up to 300 kN were introduced; there was nothing to prevent the longitudinal beams from tipping; bracings had not been fitted although required in the drawings from the supervisory engineer and the connections of the round timber members of the bracings were faulty.

Fig. 11.4 Elevation of scaffolding for the Wallenhorst railway overbridge. 1966, Case 11.9

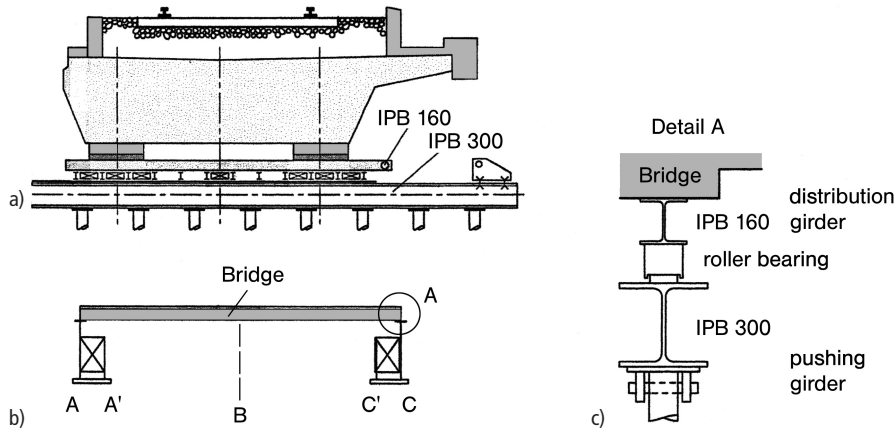
An approx. 25 m long bridge for a single-track railway overpass (the cross section is shown in Fig. 11.5a) was being constructed using a 2-span support scaffold – called the concreting scaffold – consisting of steel beams on 3 two-wall scaffolding towers adjacent to the old bridge, which was due for demolition. Fig. 11.6b shows the three towers after the partial collapse. The steel beams of the concreting scaffold were supported at the bridge ends on beams positioned on the scaffolding supports in the axes A' and C' and on axis B in the middle support.

A section of this scaffolding – known as the jacking scaffold – was to be used for sideways jacking. This construction is shown in Fig. 11.5c. The superstructure had been partially pre-tensioned on the scaffolding and therefore had the load-bearing capacity of a single-span beam during jacking.

Fig. 11.5 Partial collapse of a railway bridge between Solingen and Ohligs during sideways jacking. 1977, Case 11.29

- a) cross-section of bridge
- b) scaffolding system
- c) jacking construction

After striking the formwork, the superstructure was to lie on the IPB 160 distribution beam in axes A and C and be pushed into position on cylindrical roller bearings along the IPB 300 jacking beam (Fig. 11.5). The jacking beam lay on the head jacks of the scaffolding supports in axes A and C.

The baseplate spindles in axes A' and C' were lowered by a few centimeters to remove the formwork. This caused the scaffolding supports at the ends of the bridge to incline resulting in horizontal forces, which finally could no longer be resisted by the scaffolding towers and the jacking construction. The compressed diagonals of the bracing buckled, which increased the stress on the diagonal tension members causing them to slip in their couplings. At the same time the webs of the distribution and jacking beams became plastic.

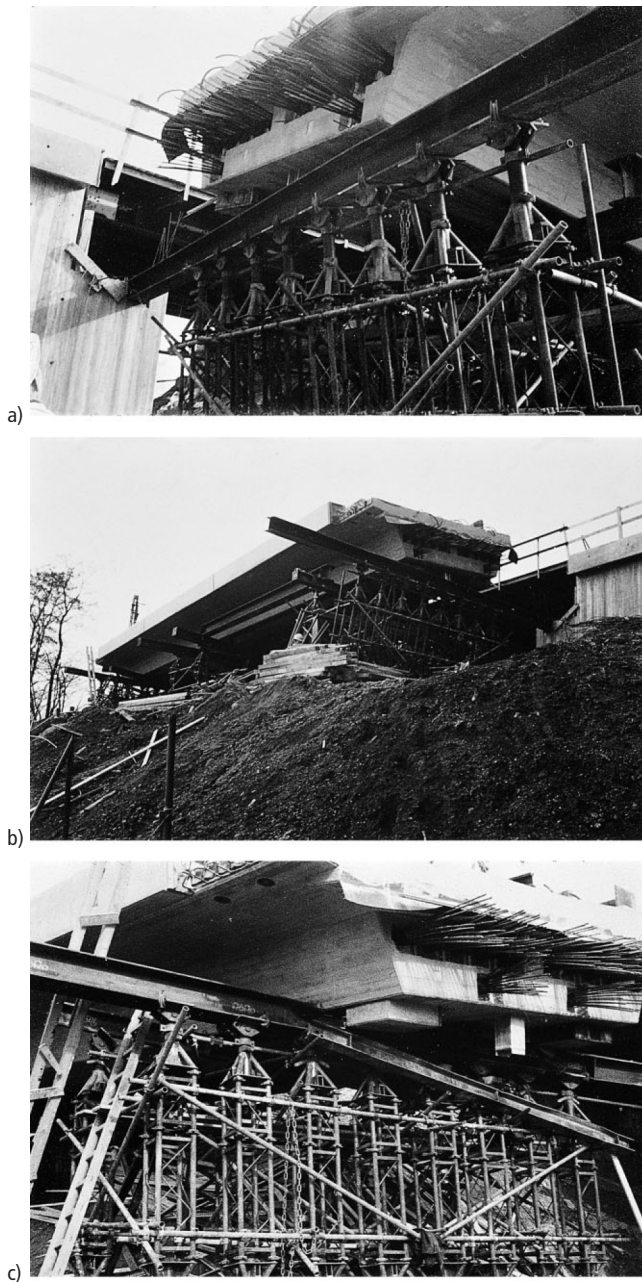
Fig. 11.6 shows the site after the collapse: (11.6b) gives a general view while Fig. 11.6a shows the north side and 11.6c the south. It can be seen that the distribution beams have fallen out and the superstructure is resting on the jacking beams.

Fig. 11.6 Scene of partial collapse of a railway bridge between Solingen and Ohligs during sideways jacking. 1977, Case 11.29

a) view of the jacking scaffold from north

b) overall view

c) view of jacking scaffold from south

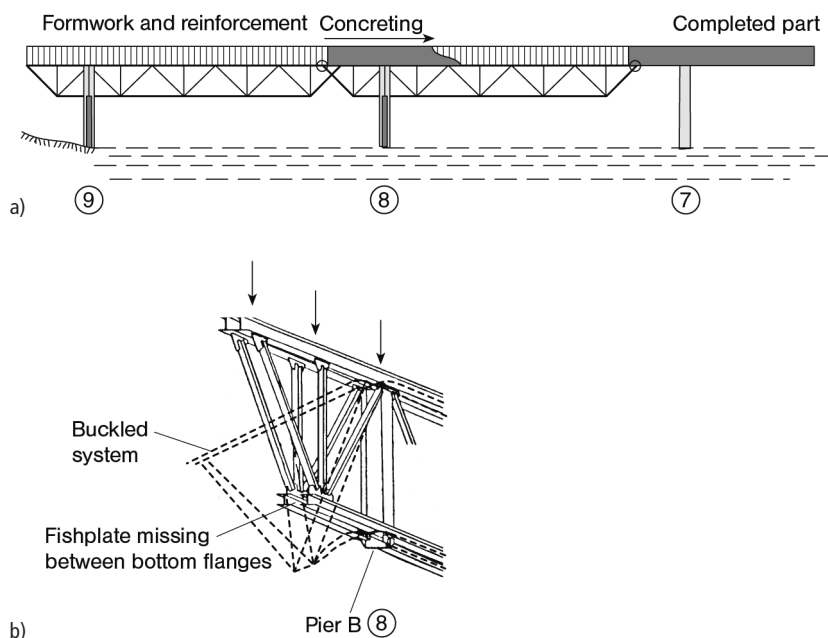
The scaffolding failed shortly after concreting had reached the support cross section. It began with lateral deformation of the bottom chords of one of the two truss beam pairs in the cantilever section (Fig. 11.7b) followed by the entire cantilever section of the concreting beam, which then caused the collapse of the formwork beam. According to reports, the entire collapse lasted about 15 minutes.

The structural analysis had assumed that the two bottom chords of each pair were held together at the tip of the cantilever by a horizontal gusset plate. But this gusset plate had

Fig. 11.7 Scaffolding for an express highway in Sweden, Case 11.48

a) scaffolding system

b) failure

been forgotten in the drawings. The truss became unstable in the area of the 1st bottom chord node with 3 compression members and 1 tension member in each truss wall and buckled.

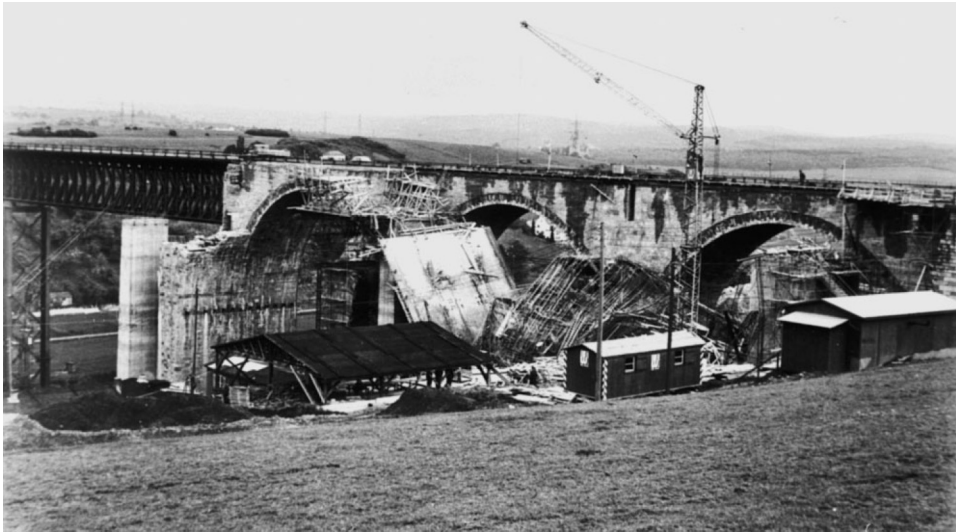
- redistribution of forces acting on the supports with a “hard” foundation on the piers of the old bridge causing overstressing and collapse (scaffolding for the Limburg motorway bridge. 1961, Case 11.7, Fig. 11.8a);
- unequal settlement of column feet due to different loads and locally different subsoil conditions, in this case fill (Case 11.8, bridge in Ludwigshafen, 1966) and to overstressing of scaffolding parts;
- misalignment of supports due to excessive soil compaction leading to unscheduled horizontal forces which, together with other causes resulted in a collapse (scaffolding of the Lösegraben bridge in Lüneburg. 1967, Case 11.11, Fig. 11.8b).

a) Limburg motorway bridge. 1961, Case 11.7

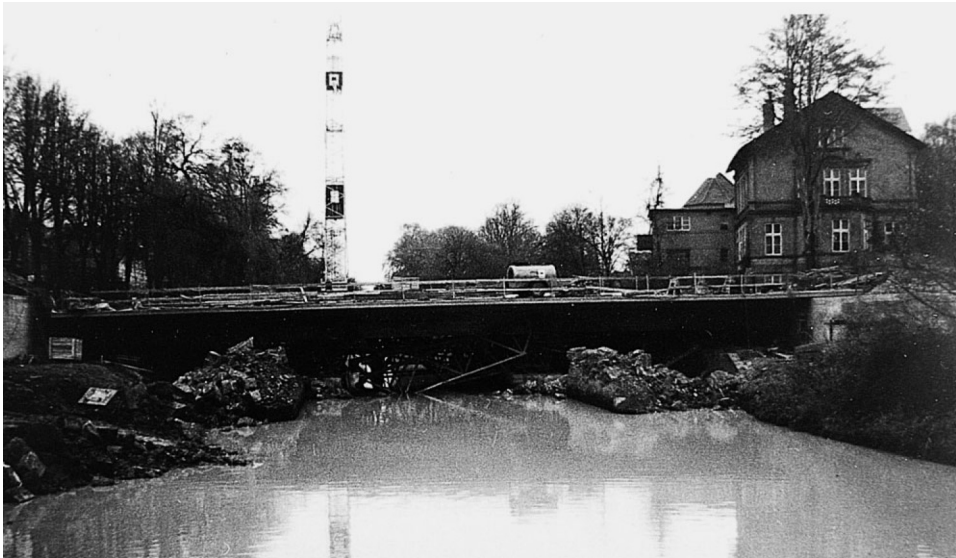
b) bridge in Lüneburg. 1967, Case 11.11

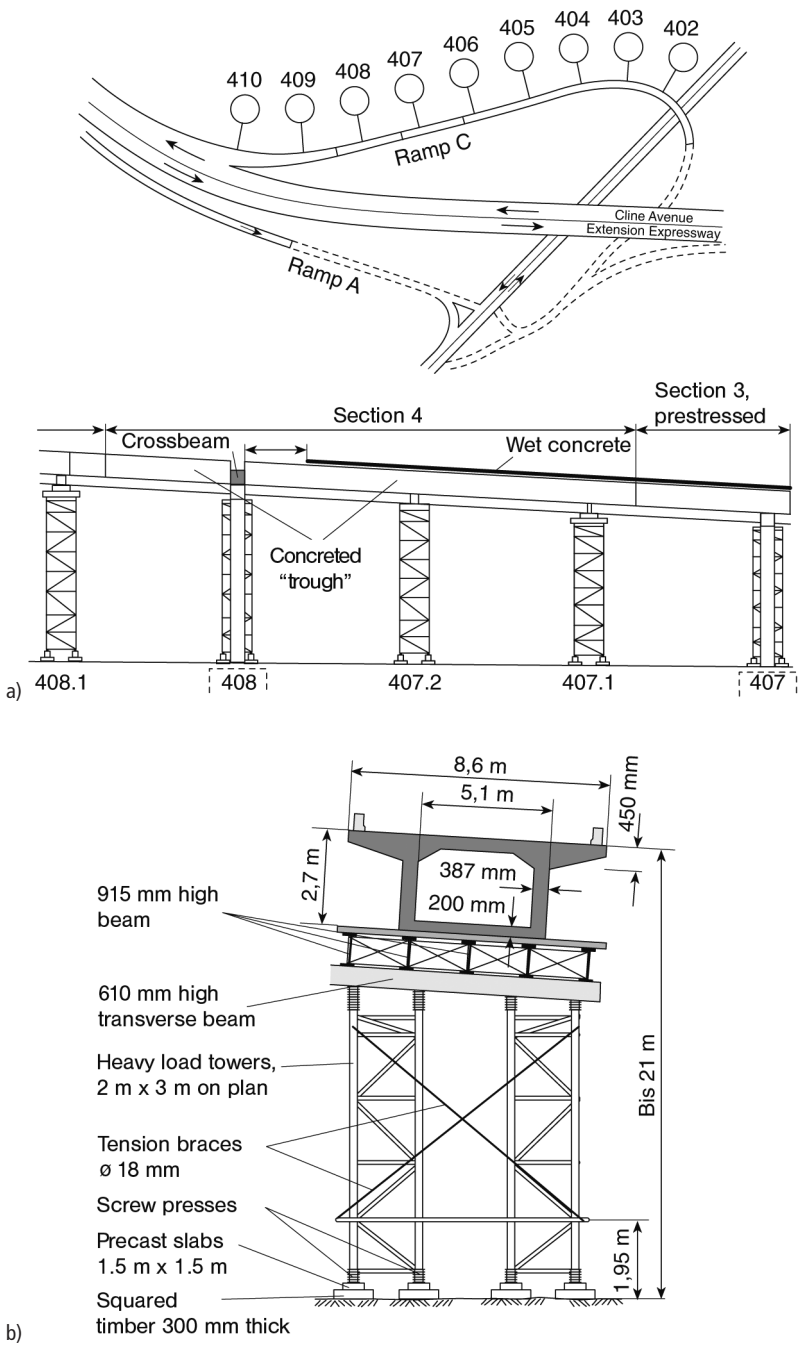
The ramp needed to connect a ground level road with an express freeway required a multi-span bridge first curved in the horizontal plane and then running in a virtually straight line (Fig. 11.9a). It was built as a prestressed concrete single cell box beam (see Fig. 11.9b for dimensions) with spans of up to approx. 55 m. According to reports the longitudinal gradient was up to 3.6 % with – as can be seen in Fig. 11.9b – a transverse gradient of up to approx. 3 %.

The foundations of the support towers at the third points were precast concrete slabs, 1.5 m x 1.5 m. Contrary to the design, these were 300 mm instead of 530 mm thick. 30 cm thick squared timbers were to be placed between the concrete slabs and the baseplates of the support towers for load distribution (Fig. 11.9b).

The ground beneath the slabs had neither been analyzed nor prepared for scaffolding although the top 1.5 to 2.7 m consisted of a fill of ashes, cinders and sand “with an oily smell”. In some areas compressible black organic mud had also been found. Soil compaction, according to the plan, must have been around 155 kN/m².

The cantilever bridge section over support 407 was completed and prestressed. The trough and the transverse bearing beam over support 408 had been concreted for the section projecting over support 408 (Fig. 11.9a). The trough was already in place for the further sections up to the end of the bridge for connection 410 to the freeway. Work was in progress to concrete the road deck from the end of the cantilever arm in front of support 407 in the direction of 408 – upwards due to the longitudinal incline – when the support tower 407.2 collapsed. The fall of the trough and the road deck, which had not yet hardened, from a height of approx.

Fig. 11.9 Scaffolding collapse during construction of a bridge in East Chicago. 1982, Case 11.33

a) system

b) cross section of shoring tower and box girder
